**Flood Control Project Maintenance
Levee Inspections**

Fall 2018 Levee Maintenance Deficiency Summary Report

**Flood Control Project Maintenance
Levee Inspections****LMA District Cover Sheet****Fall 2018 Levee Inspection Results****Sutter Maintenance Yard East Levee Sutter Bypass**

Sutter Maintenance Yard East Levee Sutter Bypass

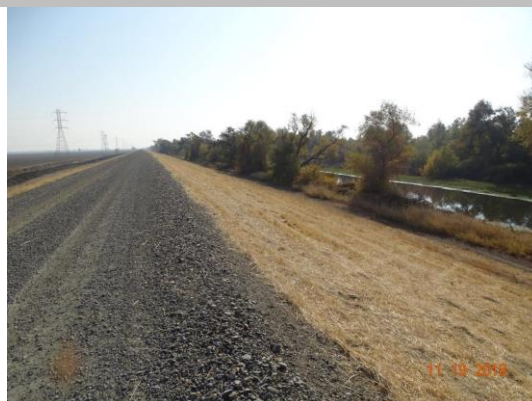
Photo 1 of 2 : FA_2018_ST0002_450_35_20181120_00077.jpg

View of no vegetation along the waterside slope.

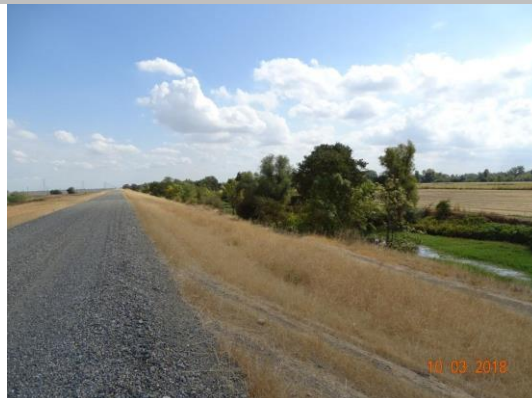
Photo 2 of 2 : FA_2018_ST0002_450_35_20181008_00073.jpg

View of the vegetation along the waterside slope.

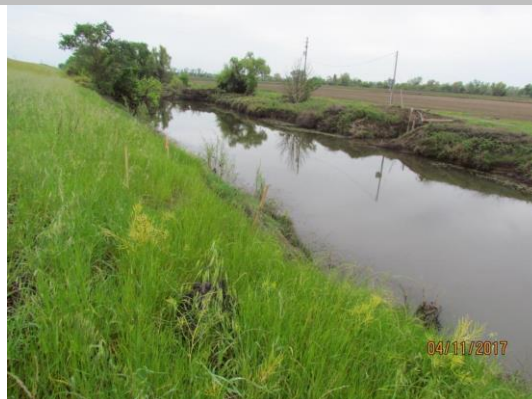
Photo 1 of 1 : FA_2018_ST0002_450_42_20180905_00010.jpg

LM Start	0.36	Rating **	M	Issue No.	42
LM End	0.36	Issue Type +	Ma	Location *	WS
Category	Earthen Levee			GPS Latitude/Longitude	
				Start	End
Item	Erosion / Bank Caving			39.147183 °	39.147183 °
				-121.828142 °	-121.828142 °
DWR ID	DWR_ST0002_01_s_2017_42				
Comment Code					
E1 : Note and monitor erosion site.					
Inspector Comment					
Repair the erosion along the water side toe.

View of the erosion along the waterside toe.

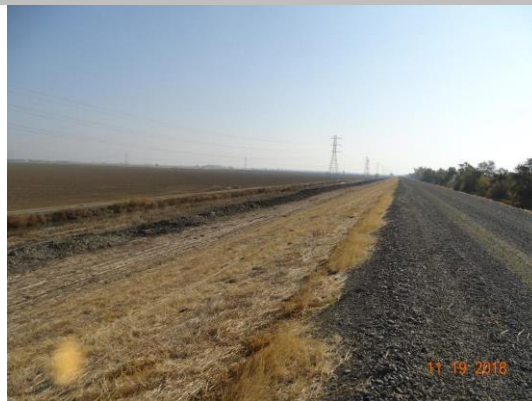
Photo 1 of 2 : FA_2018_ST0002_450_36_20181120_00078.jpg

LM Start	0.38	Rating **	A	Issue No.	36
LM End	2.62	Issue Type +	Ma	Location *	LS
Category	Earthen Levee			GPS Latitude/Longitude	
				Start	End
Item	Vegetation			39.147035 °	39.128203 °
				-121.827743 °	-121.793845 °
DWR ID	DWR_ST0002_01_f_2018_36				
Comment Code					
V2 : Remove the wild growth other than native grasses from the levee slopes.					
Inspector Comment					
The vegetation was removed from the landside slope.

View of no vegetation along the landside slope.

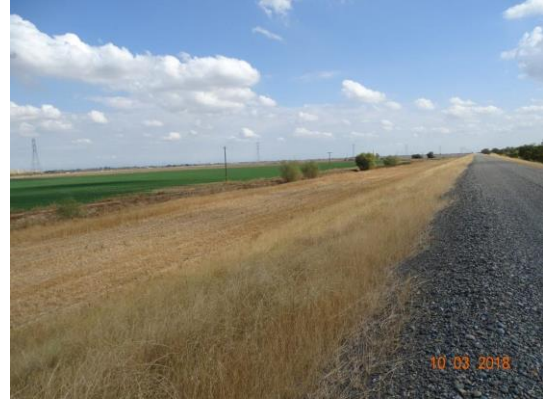
Photo 2 of 2 : FA_2018_ST0002_450_36_20181008_00074.jpg

View of the vegetation along the landside slope.

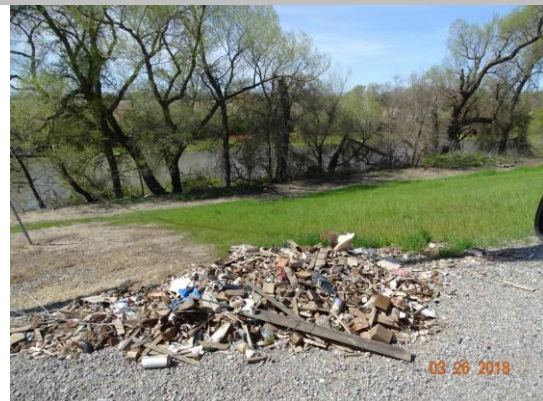
Photo 1 of 1 : FA_2018_ST0002_450_46_20180905_00013.jpg

LM Start	1.11	Rating **	M	Issue No.	46
LM End	1.11	Issue Type +	Ma	Location *	WS
Category	Earthen Levee			GPS Latitude/Longitude	
				Start	End
Item	Encroachments			39.140817 °	39.140817 °
				-121.816848 °	-121.816848 °
DWR ID	DWR_ST0002_01_s_2018_46				
Comment Code					
GA : Garbage					
Inspector Comment					
Remove the garbage from the waterside slope.

View of the garbage along the waterside slope.

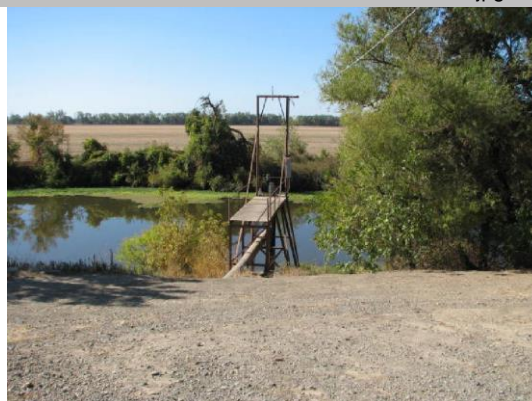
Photo 1 of 3 : UCIP_FA_2018_51560_64805.jpg

Comment Code						
Inspector Comment						
FS_ID:51560 DS_ID:16862 EP_NO: 10932 Repair Type: Non-Urgent Crossing Status: Found UCIP Comments: 4/11/2017 Riser knocked out of place on WS shoulder and no sign of the siphon breaker. Suspect it was buried. (DWR Sutter Yard- A Freitag) 10/10/2016 WS CMP riser is still knocked out of place and siphon breaker is suspected to be buried.(DWR Sutter Yard - a Freitag)4/18/2016 CMP riser is still knocked out of place and a siphon breaker cannot be found.5/7/2015 24in. cmp riser and siphon breaker were not found on the WS shoulder.11/12/2014 Same as last inspection.5/13/2014 Same as last inspection.10/30/2013 24in. cmp riser was pulled out of levee and there is no sign of a siphon breaker on WS shoulder.5/22/2013 24in. cmp riser on WS shoulder is full of garbage and dirt and should be cleaned out to inspect siphon breaker.10/8/2012 Pier has no walkway to access pump on pier. This is not necessarily an issue. FIELD_STRUCT_DESC: 16-inch coated steel irrigation pipe through the levee, 6.3 feet below the crown. Vertical pump mounted on a steel structure on the bank. Siphon breaker in a 24-inch corrugated metal pipe riser on the waterside (WS) slope. Concrete distribution box on the landside (LS). Power and communication joint pole (JP) on the WS shoulder. Original equipment in O&M. Hand drawings available in permit. (Original O&M entry removed in 1975 and replaced under Permit No. 10932, 1976 - Edward Nall) [Additional Reference(s): DWR Levee Log, 2005. USACE Sacramento O&M Manual 315, May 1953 (Station 1094+80)]. FS Date: 4/13/2017 12:49:52 PM

Pump on metal pier on WS slope.

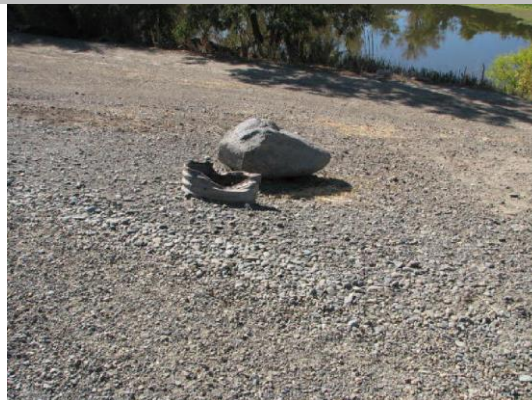
Photo 2 of 3 : UCIP_FA_2018_51560_64804.jpg

Comment Code						
Inspector Comment						
FS_ID:51560 DS_ID:16862 EP_NO: 10932 Repair Type: Non-Urgent Crossing Status: Found UCIP Comments: 4/11/2017 Riser knocked out of place on WS shoulder and no sign of the siphon breaker. Suspect it was buried. (DWR Sutter Yard- A Freitag)10/10/2016 WS CMP riser is still knocked out of place and siphon breaker is suspected to be buried.(DWR Sutter Yard - a Freitag)4/18/2016 CMP riser is still knocked out of place and a siphon breaker cannot be found.5/7/2015 24in. cmp riser and siphon breaker were not found on the WS shoulder.11/12/2014 Same as last inspection.5/13/2014 Same as last inspection.10/30/2013 24in. cmp riser was pulled out of levee and there is no sign of a siphon breaker on WS shoulder.5/22/2013 24in. cmp riser on WS shoulder is full of garbage and dirt and should be cleaned out to inspect siphon breaker.10/8/2012 Pier has no walkway to access pump on pier. This is not necessarily an issue. FIELD_STRUCT_DESC: 16-inch coated steel irrigation pipe through the levee, 6.3 feet below the crown. Vertical pump mounted on a steel structure on the bank. Siphon breaker in a 24-inch corrugated metal pipe riser on the waterside (WS) slope. Concrete distribution box on the landside (LS). Power and communication joint pole (JP) on the WS shoulder. Original equipment in O&M. Hand drawings available in permit. (Original O&M entry removed in 1975 and replaced under Permit No. 10932, 1976 - Edward Nall) [Additional Reference(s): DWR Levee Log, 2005. USACE Sacramento O&M Manual 315, May 1953 (Station 1094+80)]. FS Date: 4/13/2017 12:49:52 PM

24-inch CMP riser on WS slope.

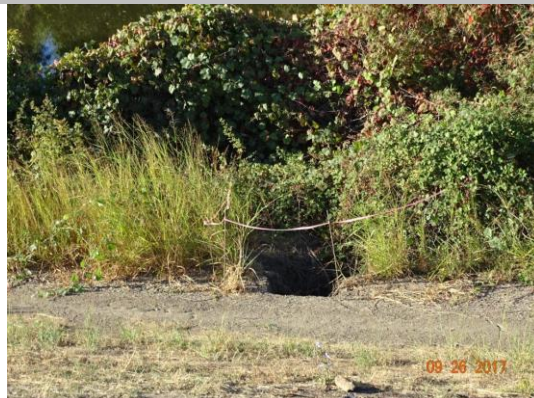
Photo 1 of 1 : FA_2018_ST0002_450_57_20180905_00014.jpg

LM Start	1.53	Rating **	U	Issue No.	57
LM End	1.53	Issue Type +	Ma	Location *	WS
Category	Earthen Levee			GPS Latitude/Longitude	
				Start	End
Item	Erosion / Bank Caving			39.137373 °	39.137373 °
				-121.810382 °	-121.810382 °
DWR ID	DWR_ST0002_01_f_2017_57				
Comment Code					
E2 : Schedule repair of erosion site prior to the next inspection.					
Inspector Comment					
Repair the beaver hole along the waterside berm.

View of the beaver hole along the waterside berm.

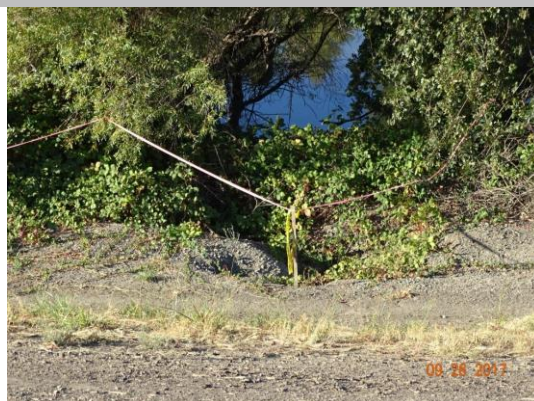
Photo 1 of 1 : FA_2018_ST0002_450_58_20180905_00015.jpg

LM Start	1.57	Rating **	U	Issue No.	58
LM End	1.57	Issue Type +	Ma	Location *	WS
Category	Earthen Levee			GPS Latitude/Longitude	
				Start	End
Item	Erosion / Bank Caving			39.137010 °	39.137010 °
				-121.809673 °	-121.809673 °
DWR ID	DWR_ST0002_01_f _ 2017_58				
Comment Code					
E2 : Schedule repair of erosion site prior to the next inspection.					
Inspector Comment					
Repair the beaver hole along the waterside berm.

View of the beaver hole along the waterside berm.

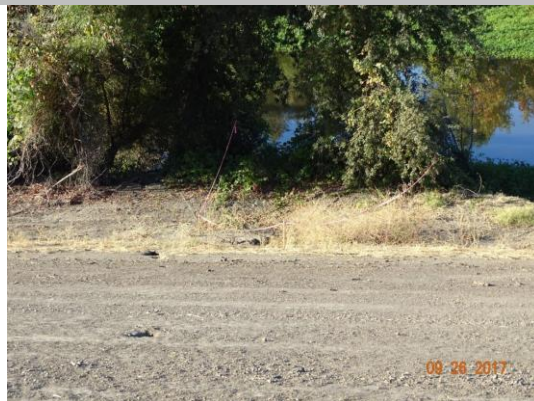
Photo 1 of 1 : FA_2018_ST0002_450_61_20180905_00016.jpg

LM Start	1.61	Rating **	U	Issue No.	61
LM End	1.61	Issue Type +	Ma	Location *	WS
Category	Earthen Levee			GPS Latitude/Longitude	
				Start	End
Item	Erosion / Bank Caving			39.136713 °	39.136713 °
				-121.809202 °	-121.809202 °
DWR ID	DWR_ST0002_01_f_2017_61				
Comment Code					
E2 : Schedule repair of erosion site prior to the next inspection.					
Inspector Comment					
Repair the beaver hole along the waterside berm.

View of the beaver hole along the waterside berm.

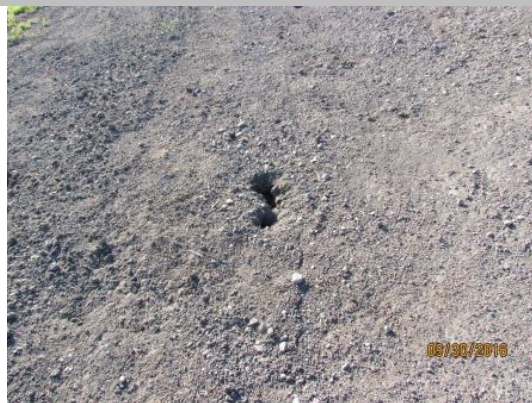
Photo 1 of 1 : FA_2018_ST0002_450_26_20180905_00005.jpg

LM Start	4.81	Rating **	M	Issue No.	26
LM End	4.81	Issue Type +	Ob	Location *	LS
Category	Earthen Levee			GPS Latitude/Longitude	
				Start	End
Item	Cracking			39.108110 °	39.108110 °
				-121.762623 °	-121.762623 °
DWR ID	DWR_ST0002_01_f_2016_26				
Comment Code					
CR1 : Monitor and have inspected by geotechnical engineer.					
Inspector Comment					
Longitudinal cracks caused by fat clay.

View of the longitudinal cracks.

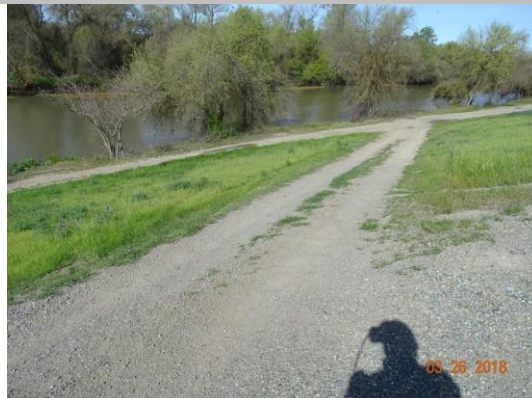
Photo 1 of 1 : FA_2018_ST0002_450_45_20180905_00012.jpg

LM Start	5.19	Rating **	M	Issue No.	45
LM End	5.19	Issue Type +	Ma	Location *	WS
Category	Earthen Levee			GPS Latitude/Longitude	
				Start	End
Item	Slope Stability			39.103368 °	39.103368 °
				-121.758760 °	-121.758760 °
DWR ID	DWR_ST0002_01_s_2018_45				
Comment Code					
S3 : Repair the levee slope damaged by vehicle traffic and prevent access where possible.					
Inspector Comment					
Repair the slope damaged by vehicle traffic.

View of the vehicle traffic along the waterside slope.

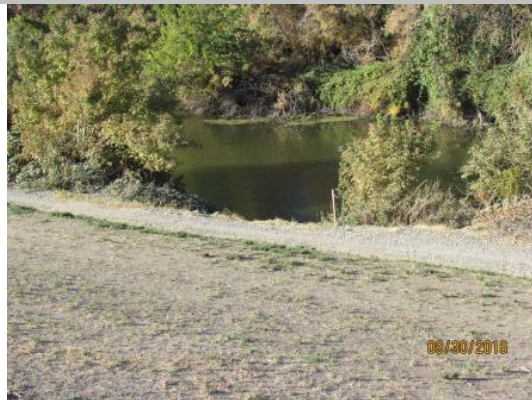
Photo 1 of 1 : FA_2018_ST0002_450_34_20180905_00007.jpg

View of the erosion along the waterside toe.

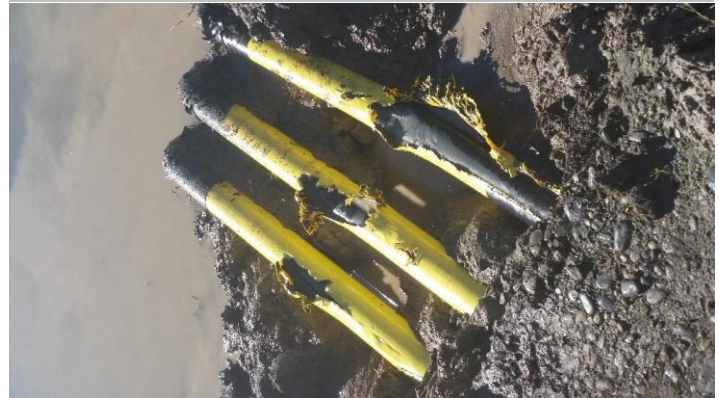
Photo 3 of 3 : UCIP_FA_2018_53446_74958.jpg

FS_ID:53446
DS_ID:16884
EP_NO: 14455
Repair Type: Non-Urgent
Crossing Status: Indicator Found
UCIP Comments: 10/04/2018 Crossing has been downgraded from Urgent to Non-Urgent. Slopes are stable. WS toe was stabilized with rock. Need to contact utility owner to determine the status of the line. Unable to determine if the line is abandoned or active therefore crossing remains classified as a Non-Urgent issue. (O. Magana - DWR UCIP)
4/11/2017 The damage to the levee toe was repaired by Sutter Maintenance Yard. The hole was filled in and compacted with rock. The repairs have not yet been made to the gas line by the gas line owners but the damage does not affect the integrity of the levee or bank. Photos updated. (DWR Sutter Yard - A Freitag) 10/18/2016 it is unknown if the damage to the levee toe from the farmer getting his tractor stuck has been repaired (DWR UCIP - thatch)
10/10/2016 Crossing appears to be in good condition but im not sure if the damaged pipe section at the WS berm was ever repaired. (DWR Sutter Yard - a Freitag) 4/18/2016 Gas line was damaged at the WS berm due to a farmer getting his tractor stuck. Gas company is aware of the damage and will be doing repairs sometime this summer. Damage should not affect the integrity of the levee. (DWR Sutter Yard - a Freitag) 5/7/2015 Marker on WS broken. (DWR Sutter Yard - a Freitag) 11/12/2014 Same as last inspection. (DWR Sutter Yard - a Freitag) 5/13/2014 Same as last inspection. (DWR Sutter Yard - a Freitag) 10/30/2013 Same as last inspection. (DWR Sutter Yard - a Freitag) 5/22/2013 Carsonite marker on WS shouder is broken and should be replaced. (DWR Sutter Yard - a Freitag)

Damaged gas lines at the WS berm.

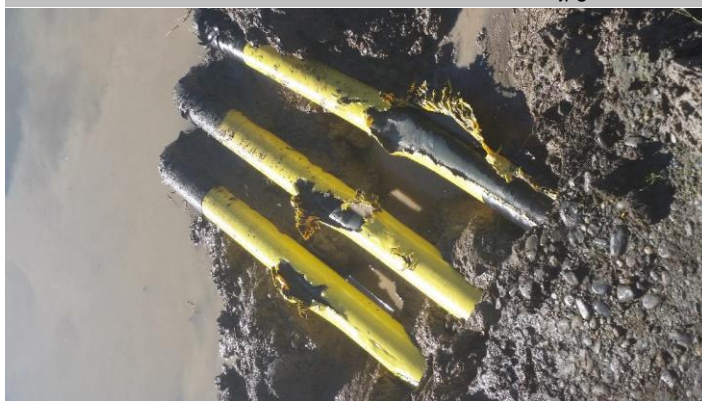
Photo 3 of 3 : UCIP_FA_2018_53447_74959.jpg

Damaged gas lines at the WS berm.

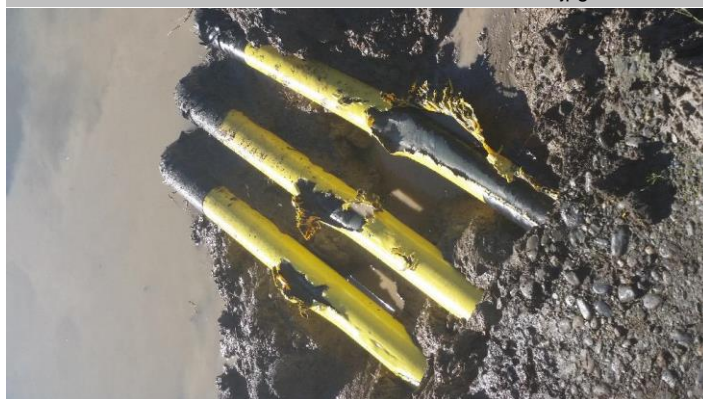
Photo 3 of 3 : UCIP_FA_2018_53448_74960.jpg

Damaged gas lines at WS berm.

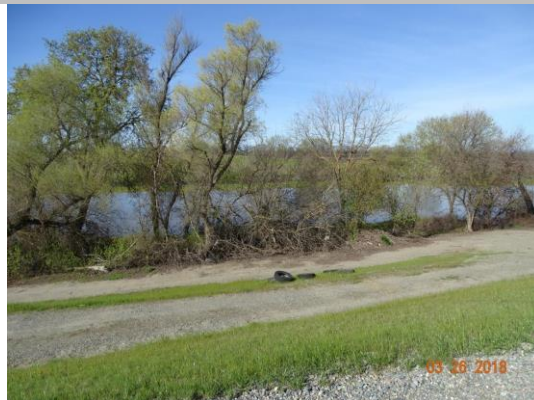
Photo 1 of 1 : FA_2018_ST0002_450_44_20180905_00011.jpg

View of the tires along the waterside slope and toe.

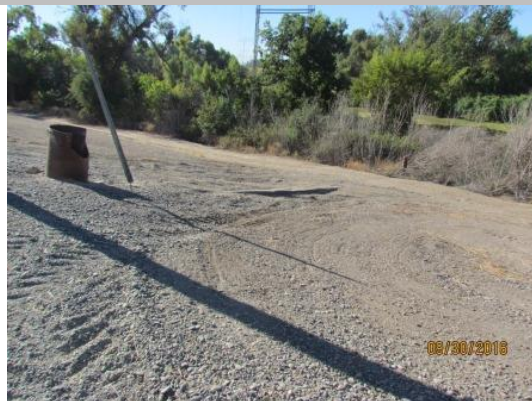
Photo 1 of 1 : FA_2018_ST0002_450_37_20180905_00008.jpg

View of the erosion caused by vehicle traffic.

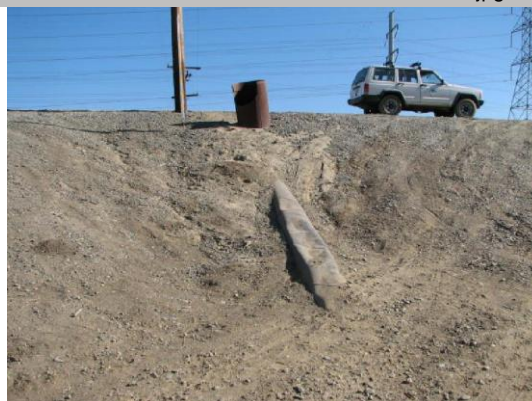
Photo 3 of 3 : UCIP_FA_2018_51605_65312.jpg

Crushed pipe on WS slope.

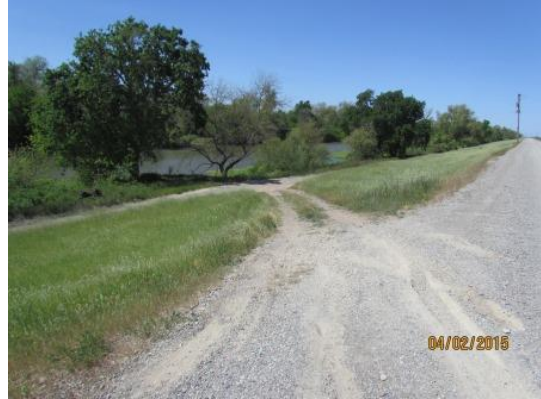
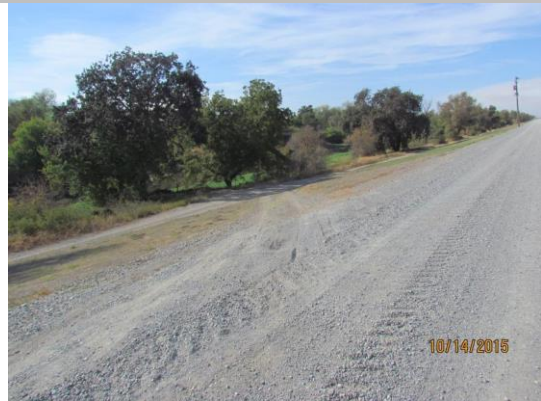
View of the vehicle erosion along the waterside slope.

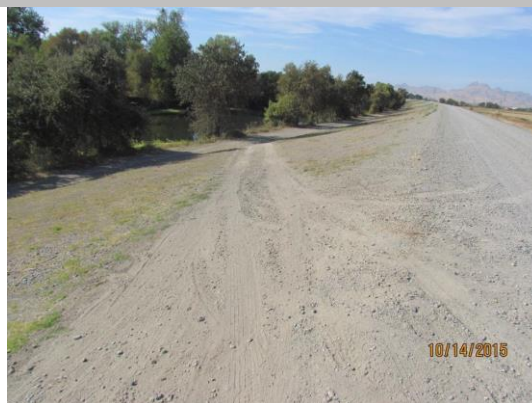
Photo 1 of 1 : FA_2018_ST0002_450_29_20180905_00006.jpg

View of the vehicle erosion along the waterside slope.

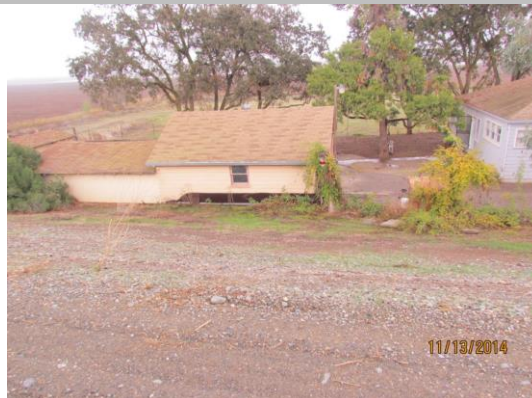
Photo 1 of 1 : FA_2018_ST0002_450_10_20180905_00001.jpg

View of the house next to the toe of the levee.
